Erosion control & Shoreline protection

Strategies for :
Dealing with the impact of climate change on
cultural heritage.

Case introduction: Stone Old Man

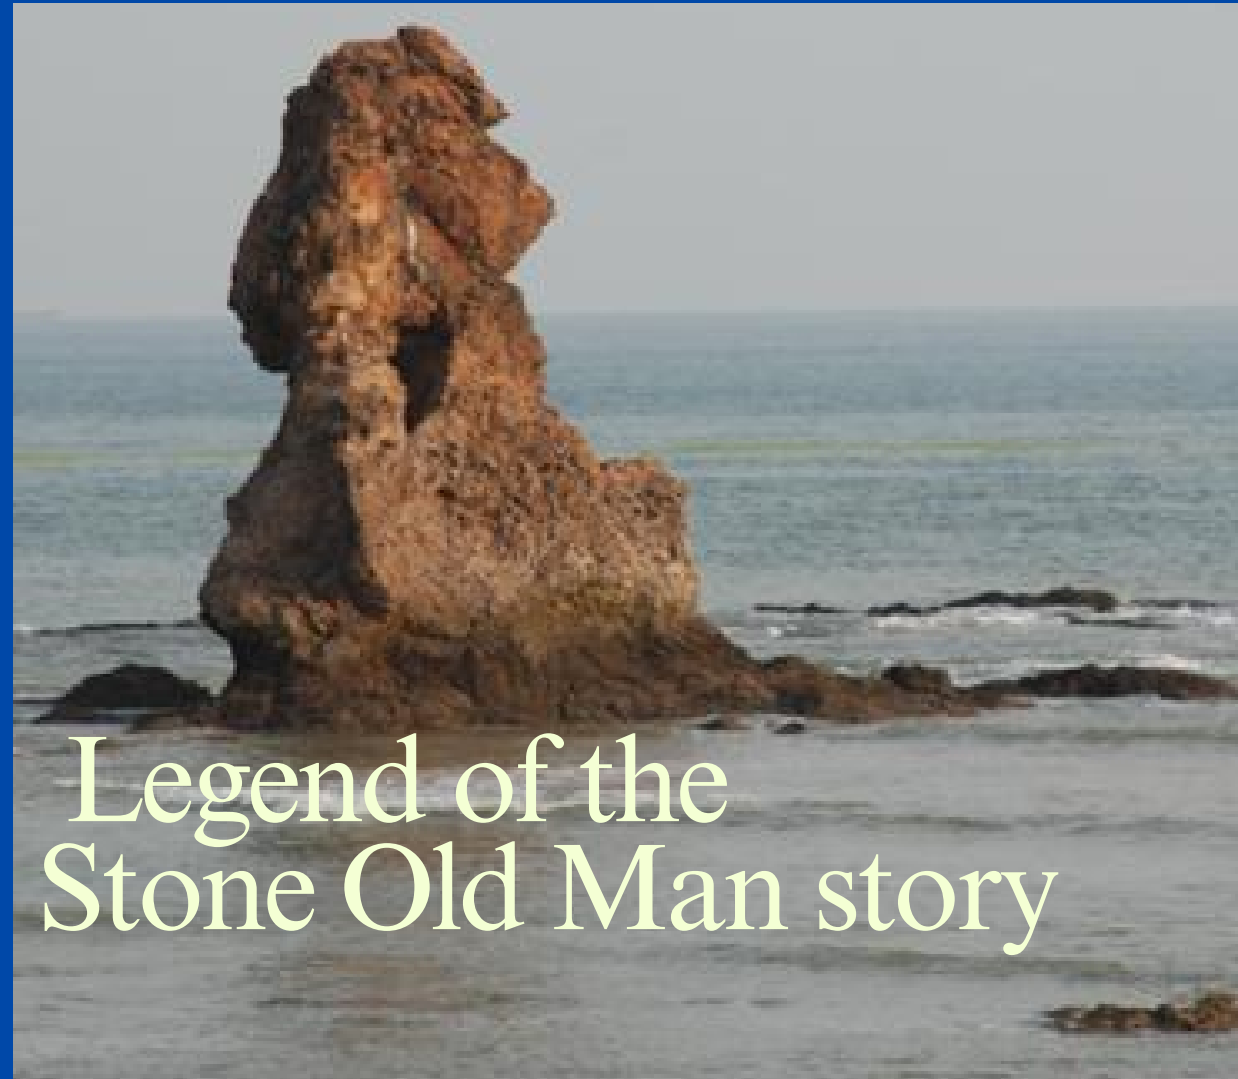
Stone Old Man is a typical sea-erosion column landscape on the coast, standing in Qingdao City for 6,000 years. Due to its special shape, it became an iconic landmark in Qingdao Tourism, also a famous location for movie shooting.

It is also the first batch of intangible cultural heritage of Shandong Province. Unfortunately, it collapsed in October 2022 with the head falling, stones of the arms and hips falling and disappearing one after another.

Reason for the fall: According to experts' on-site investigation, it is believed that due to perennial weathering and seawater erosion, coupled with the recent years climate changes, resulted in the natural collapse of the upper part of the Stone Old Man.

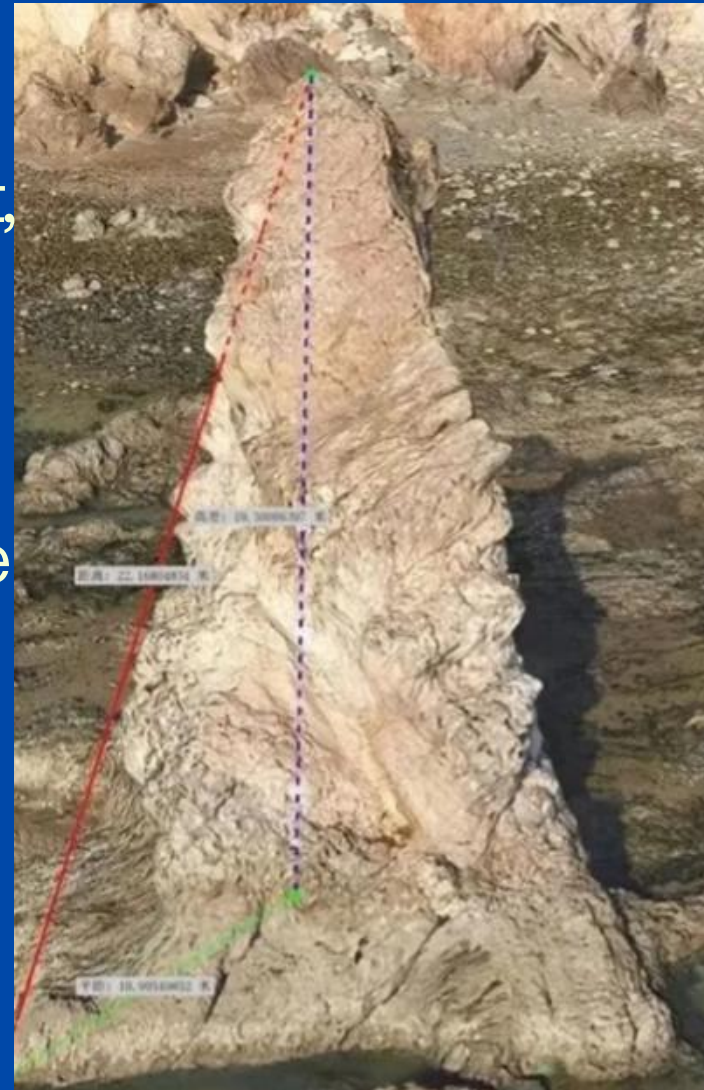
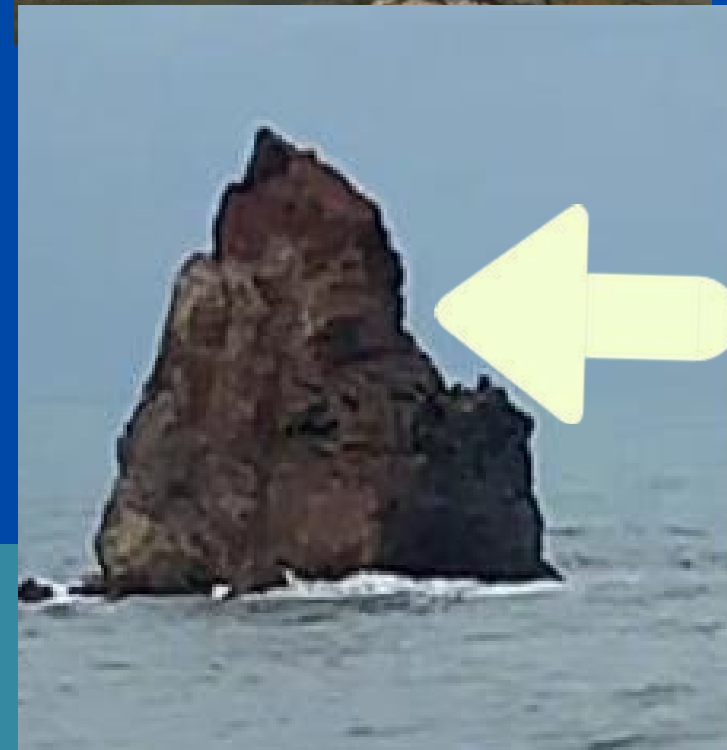
Step 1: Digital heritage live 3D model

In 2021, the construction of a realistic 3D Qingdao was carried out, using technology about tilt aerial photography and laser 3D scanning to "move" the city into the computer with a higher accuracy of 3 cm in the main city.

The Stone Old Man was also collected, presented a complete realistic three-dimensional model in the computer, and has the characteristics of measurable, high precision, providing reliable data for the its restoration.

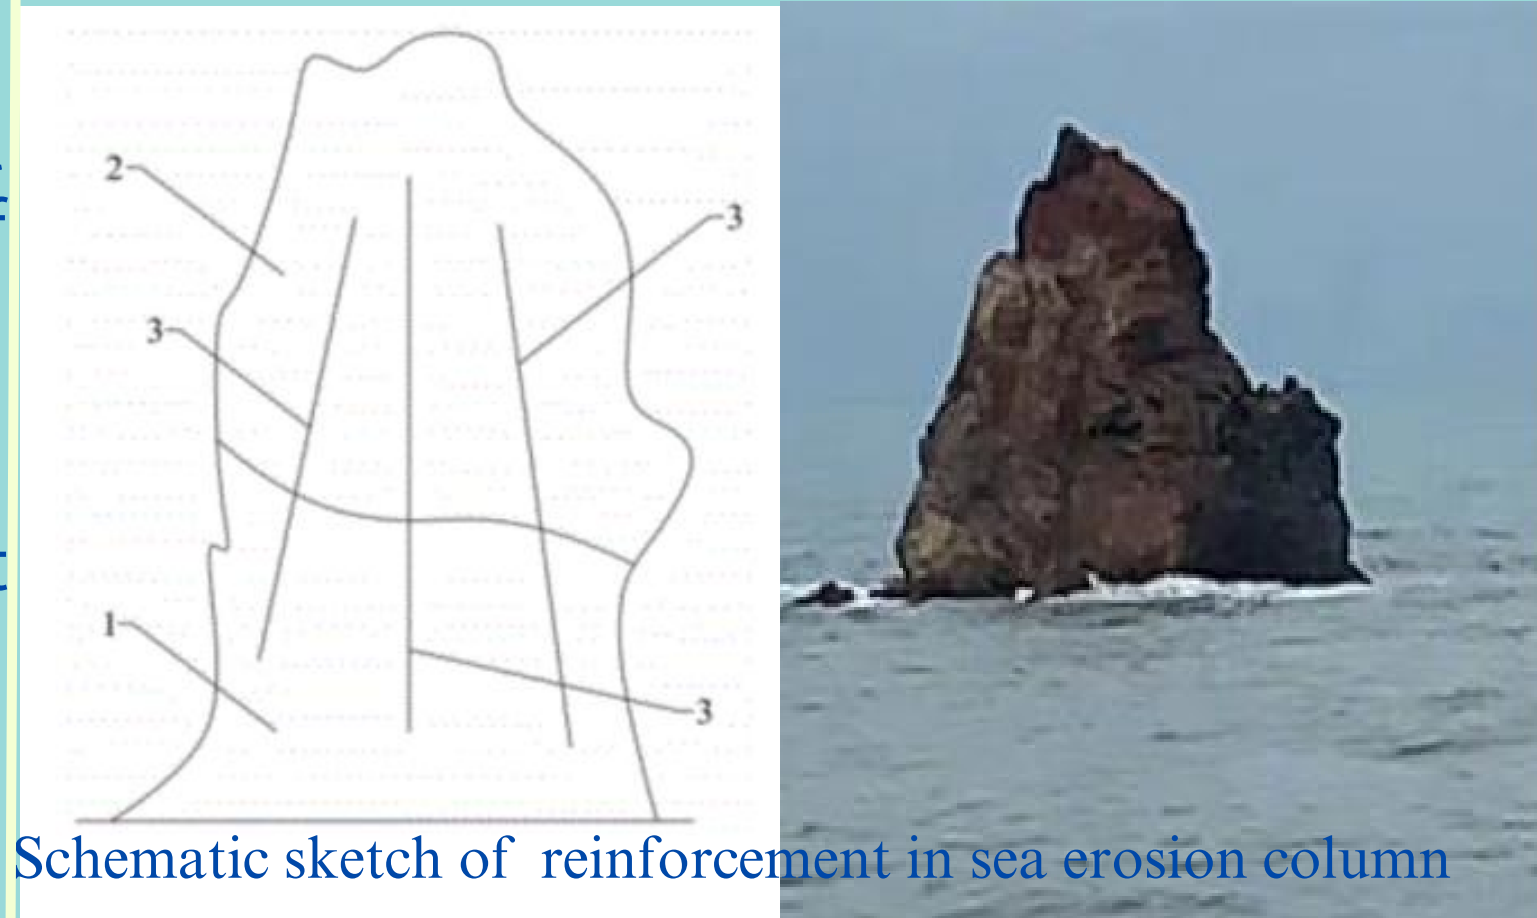
• Remodeling of collapsed parts:
Screening classification: For the collapsed sea erosion column into several parts, the remaining base of the column is used as the basis, and other parts are divided into major and minor parts according to the screening conditions.

By carrying out four restorations in incremental steps, under the premise of the original technology MICP microbial slurry, together with the supporting and fixing effect of steel reinforcement, it makes the restored sea erosion column more stable.

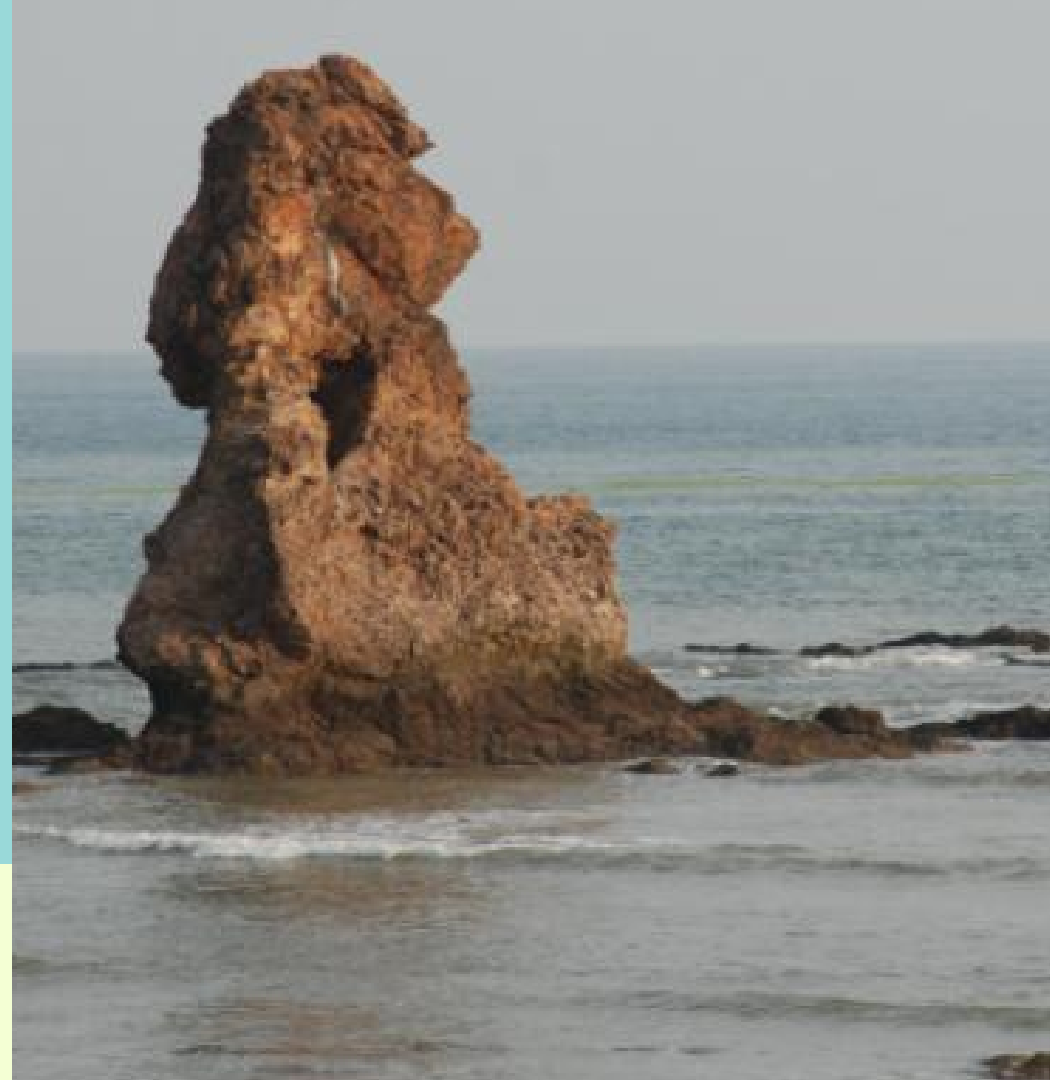
Four repairs:

- 1 Primary restoration: Reinforcement to base connection with microbial slurry dip.
- 2 Secondary repair: Backfilling the recessed position of the sea erosion column with filler and grouting with microbial slurry.
- 3 Third repair: Fissure grouting to solidify.
- 4 Final restoration: Spraying microbial slurry on the outer surface of column to form an overlay, completing the restoration.
